# Semi-Submersible, Top Drive Gearbox, Gear Oil CJC® Oil Filtration

Drilling operator, drilling rig, semi-submersible.

**System:** Top drive gearbox  
**Oil type:** Shell Omala S4 WE 220  
**Viscosity:** ISO VG 220  
**Oil volume:** 180 L

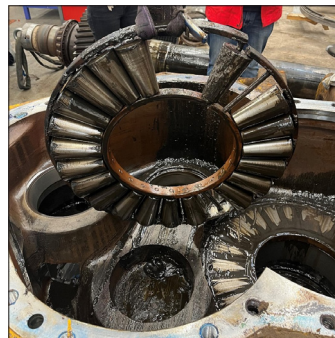
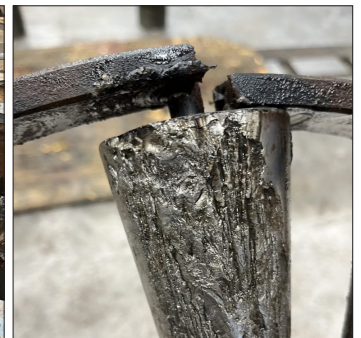
All sensor values were indicating such severe oil contamination level, that even the CJC® Oil Filter was not able to keep up. It turned out that the gearbox was in the process of breaking down - the CJC® Oil Filter and Monitoring Unit was installed in the final part of the breakdown. The gearbox was beyond saving, and a total breakdown occurred, with an estimated cost of more than 2 mio. USD in spare parts and lost production.

Defect Top Drive gearbox due to contaminated oil

A CJC® Oil Filter HDU 15/25 with CJC® CMU Condition Monitoring Unit and a CJC® T<sup>2</sup>render Pro subscription was installed using CJC® Filter Insert BG 15/25 with a dirt holding capacity of 1 kg. The purpose of the system is to remove contamination from the gearbox oil and to detect abnormal gearbox behaviour using the T<sup>2</sup>Render PRO subscription.
