## CJC™ Application Study

BMA. Coal Loading Terminal, Hay Point, Queensland Australia.

David Brown gearbox, 180 L of BP GRXP 320 (ISO VG 320). The gear box is driving a conveyor belt, which transports coal.

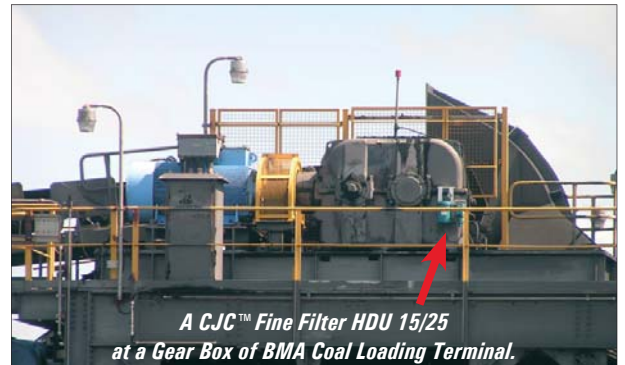
*A CJC™ Fine Filter HDU 15/25 at a Gear Box of BMA Coal Loading Terminal.*

A CJC™ Fine Filter HDU 15/25 PV was installed with a flow rate of 45 litres per hour and using a CJC™ Filter Insert BG 15/25 with a dirt hol-ing capacity of 1.5 litres.

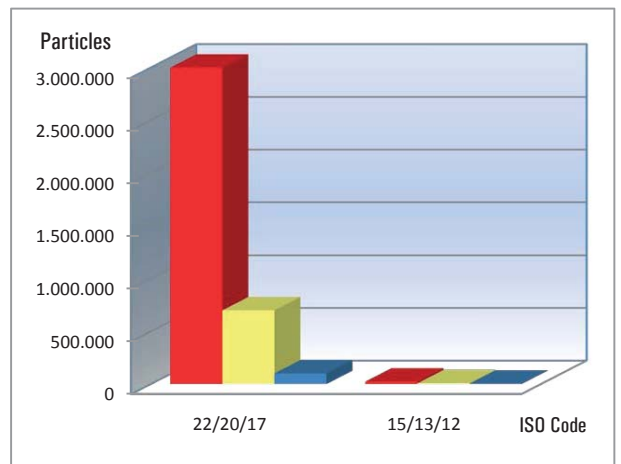
### PARTICLE REDUCTION

Particles	ISO code
Before	> 22/20/17
After	15/13/12

Upon start up a result of greater than ISO 22/20/17. The contamination in the oil was greatly reduced over a 42 day period. The ISO particle count on day 42 is 15/13/12.
