CJC® Varnish Removal Unit VRU

# GUIDE to Varnish Removal from oils in Gas & Steam Turbines

## Gas & Steam Turbine GE 109FA, Combined Cycle Single Shaft

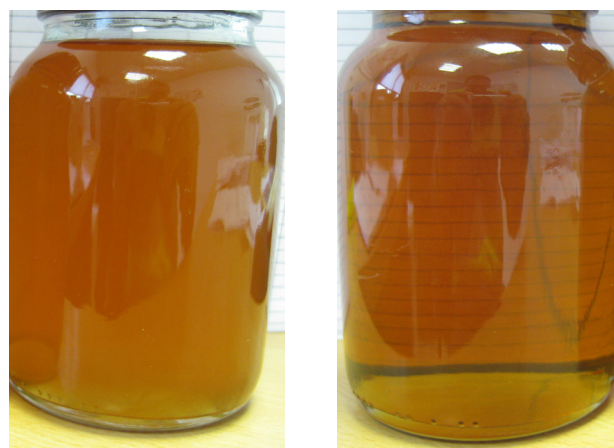
Appearance of the oil after sampling at the CJC® VRU Filter - Inlet & Outlet.

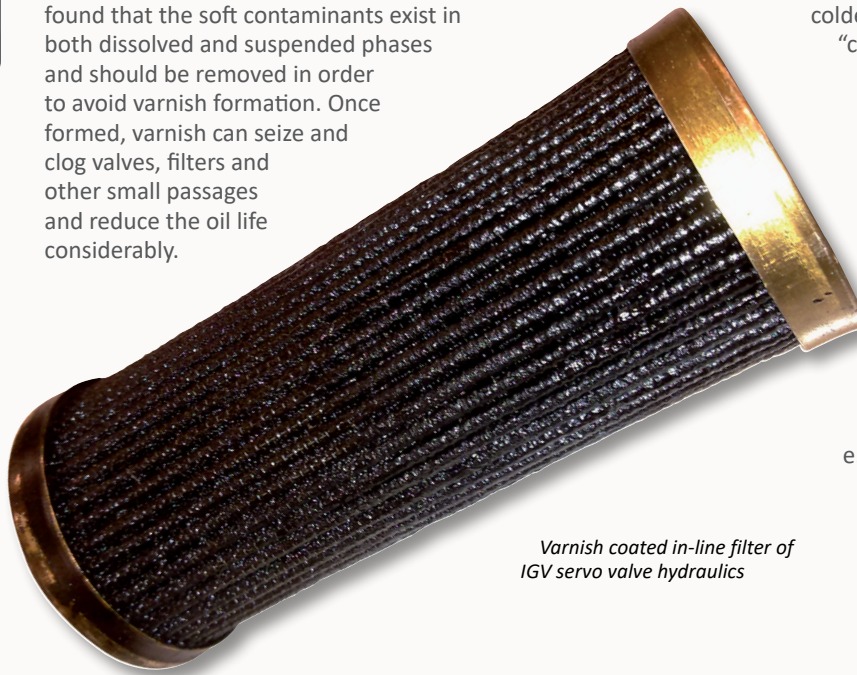
*Varnish coated in-line filter of IGV servo valve hydraulics*

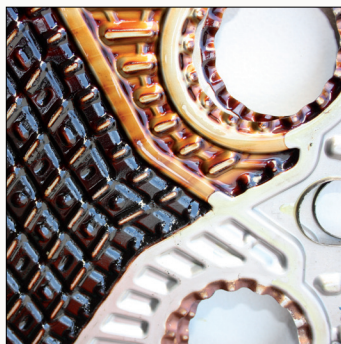
*Varnish on plate heat exchanger*

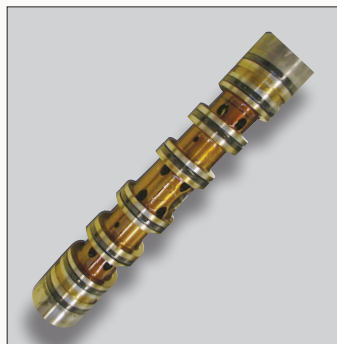
*Varnish on valve spool*
