Turbine Lube Oil Electric Power Plant, Gas Turbine

CJC™ Application Study

General Electric 7FA Gas Turbine.

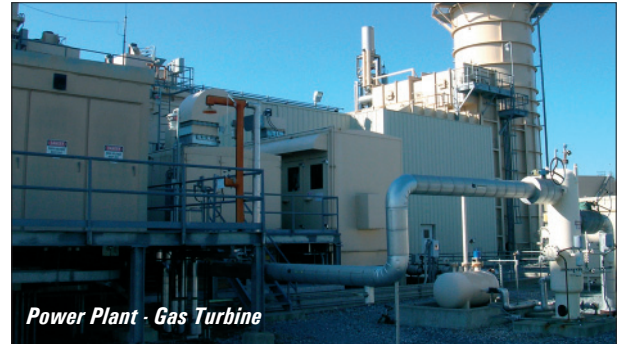
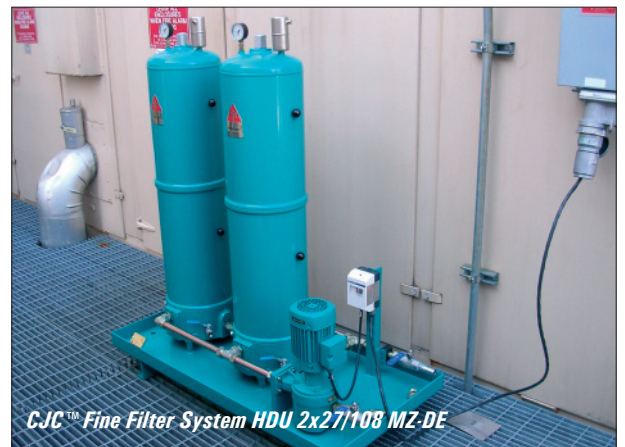
Oil samples were taken prior to installation and sent to an independent oil analysis laboratory for testing. Regular samples were taken and the results compared. A sub micron particle count was the key test since varnish particles are typically 0.2 - 2 µm.

The turbine operated 9 hours from December through May. The minimal run time allowed the CJC™ Fine Filter to clean the oil in the reservoir many times over, polishing the oil. During the month of June the turbine run time increased by 250 hours allowing the ultra clean oil in the reservoir to circulate throughout the turbine lube oil system. As a result, the ultra clean oil acted as a solvent, removing oxidation deposits from internal surfaces. This caused a surge in sub micron particles. Continuous filtration with the CJC™ Fine Filter significantly lowered the high level of particles before the end of June.

The varnish level was reduced as observed in the sub micron particle count and the entire lube system was cleaned. More importantly, a reduction in unit trips was observed and recorded.
