# Lube Oil

## Steam Turbine, Siemens SST-400, 65 MW

**TIRME Environmental Technology Park Mallorca.**  
Urban waste management plant.

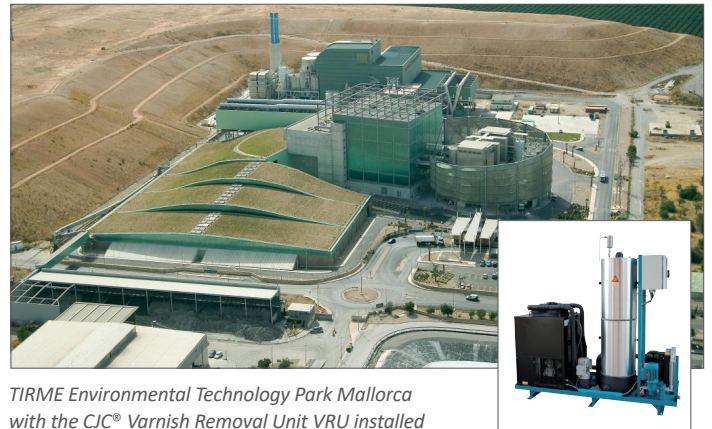
TIRME Environmental Technology Park Mallorca with the CJC® Varnish Removal Unit VRU installed

A **CJC® Varnish Removal Unit, VRU 27/108** with **CJC® Varnish Removal inserts VRi** was installed.

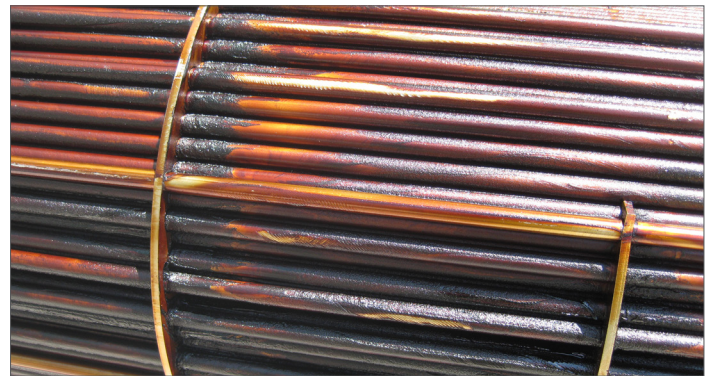
The high level of varnish detected during the periodic overhaul checks led to a corrective plan. The recorded average MPC values of above 30, indicated high failure risk of heat exchangers, valves and bearings, due to contamination with varnish and oil degradation products in the turbine.

Heat exchanger failure due to varnish build-up on the surface

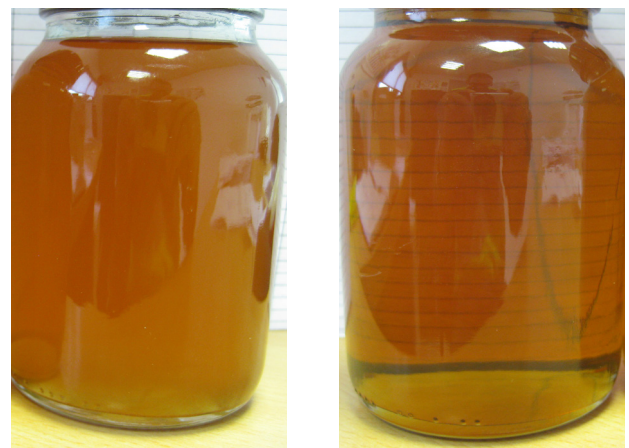
Appearance of the oil after sampling at the CJC® VRU Filter - Inlet & Outlet.

BEFORE CJC® VRU oil filtration	AFTER 47 days CJC® VRU oil filtration	AFTER 2 years CJC® VRU oil filtration
MPC Value	41.6	<b>16.3</b>	13.6

The MPC decreased from 41.6 to 16.3 over a period of 47 days. Due to thick layers of varnish deposited on the coldest surface areas in the system, filtration with the CJC® VRU was required for 2 years to stabilise the MPC value to below 15.
