COMBINED CYCLE Journal

User group gets an assist on fan gearbox lube-oil solution

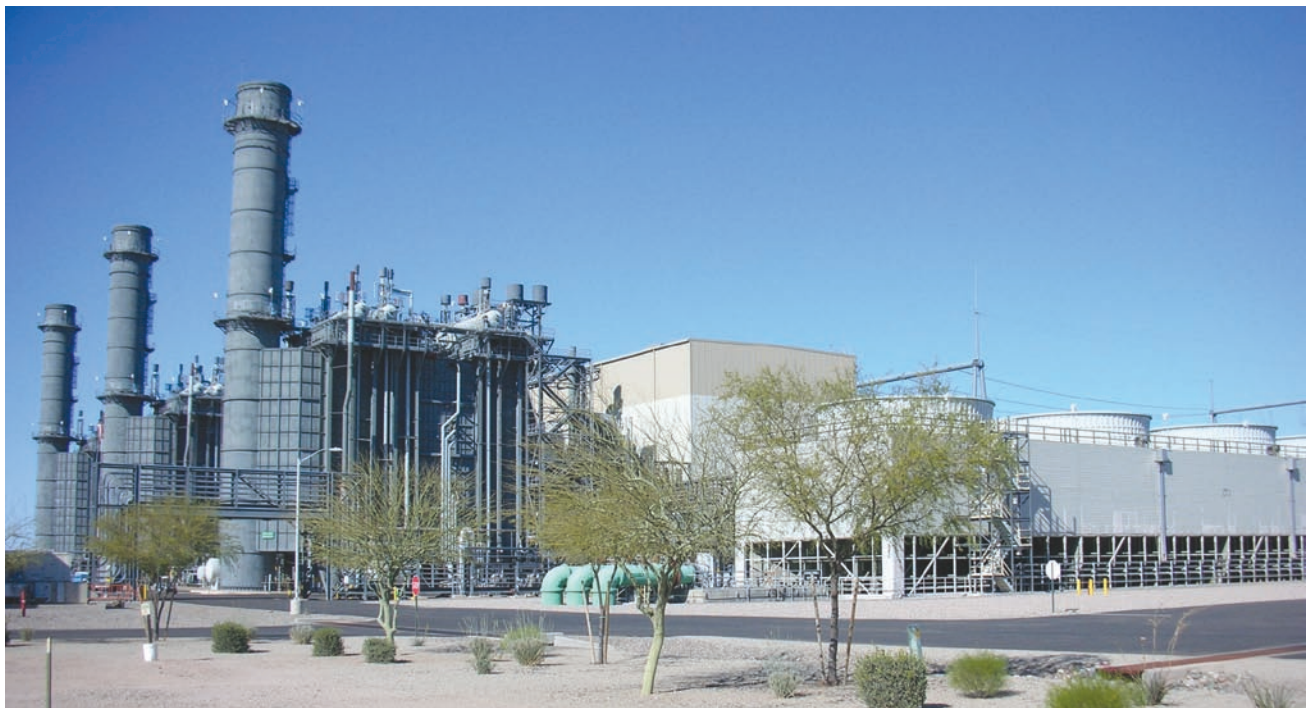
1. New Harquahala Generating Co is an 1100-MW plant with three 1 × 1 combined cycles powered by Siemens Energy SGT6-6000G (W501G) engines

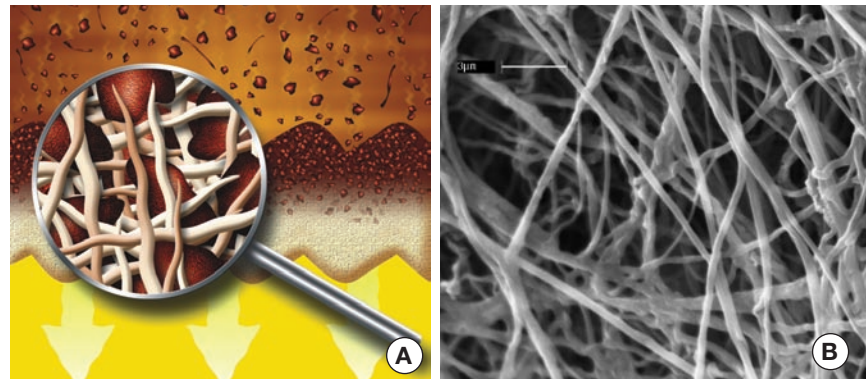
2. Particulates in the lube-oil system are trapped and retained by microscopic organic fibers. Nearly 99% of all solid particles in the oil stream larger than 3 microns are removed on each pass

The bonded disks that comprise the Jensen filter medium, made primarily of compressed wood cellulose and cotton linters, are designed to retain on each pass 98.7% of all solid particles larger than 3 microns and approximately 50% of all particles larger than 0.8 microns. The simplified sketch in Fig 2 illustrates how particulates are trapped by the fibers, which are shown under a microscope in the adjacent photo. You’ve probably seen similar sketches and photos from many other vendors selling filters for water, oil, and air.

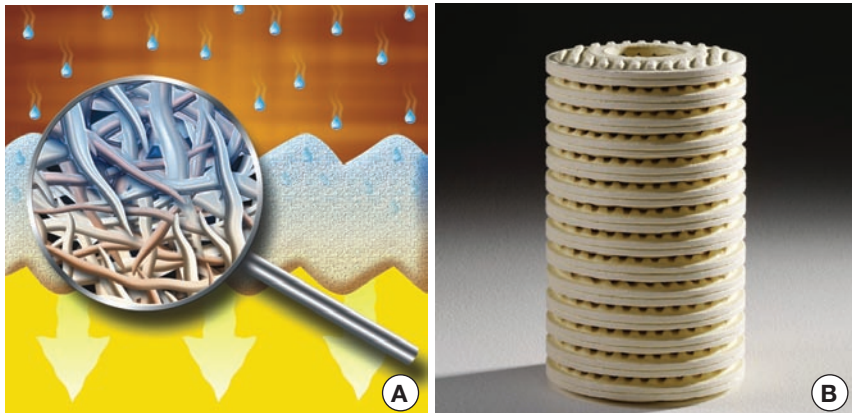
3. Water is absorbed by the filter medium used in small-volume systems

two ways at New Harquahala—absorption and separation. The bonded disks described in the preceding paragraph also are designed to absorb water when serving small sumps (Fig 3A). The filter inserts for the Arizona plant’s cooling-tower gearboxes, and GT and ST control-oil sumps, have a holding capacity of 1.5 liters of evenly distributed solids, or up to 750 ml of water and solids the balance of the 1.5 liters (Fig 3B).

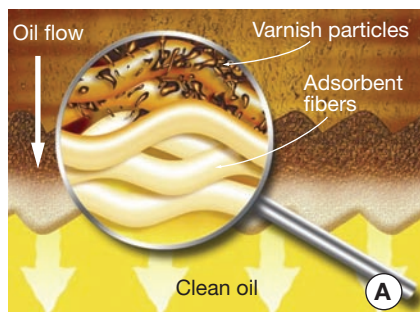
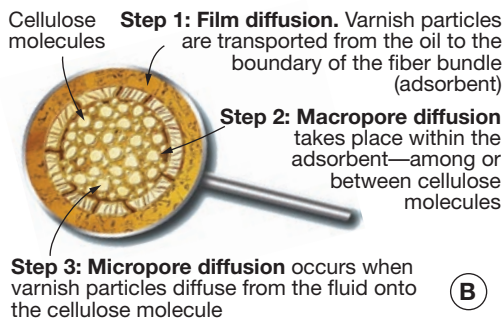
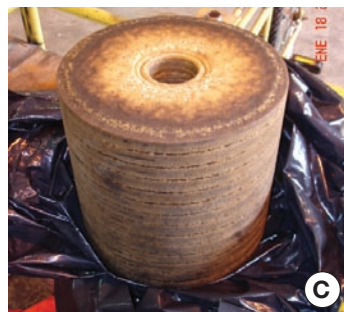
5. Adsorption of varnish is described by the sketch in A. The clean oil leaving the cellulose filter helps to dissolve remaining deposits in the system so they also can be removed. Cross section of a cellulose fiber (B) illustrates how the diffusion process works to capture and retain varnish particles. Filter insert in C has half of its holding capacity occupied by varnish molecules

Varnish removal. When varnish particles pass by an adsorbent, they attach to its surface (Fig 5A). Cellulose is particularly effective in this regard; its high polarity is well suited to attracting oxygenated molecules—such as varnish. Wegner stressed that this was a “natural” process—no voltage required, no control system, etc. Capacity is determined solely by surface area. He said that just one gram of cellulose has a surface area of about 4000 ft² and that a standard filter cartridge contains 3600 grams of cellulose; you do the math.

Exactly what happens inside the filter media is described in Fig 5B. Here’s a more detailed explanation of the terms used in the drawing: Diffusion is the transport of matter (varnish in this case) from one point (the oil) to another (the filter media). Film diffusion describes how the varnish molecules are drawn to the boundary of the cellulose fiber by means of the inherent physical forces (polarization, electrostatic, and hydrogen bonding).

Once “inside,” the varnish molecules move among, or between, the cellulose molecules in open spaces. The spaces are large relative to the size of the molecules, hence the term macropore diffusion. Next, the varnish molecules come to rest on the adsorbent surface—that is, they diffuse from the fluid onto the cellulose molecule (micropore diffusion). Fig 5C shows a filter insert with half of its holding capacity occupied by varnish molecules.

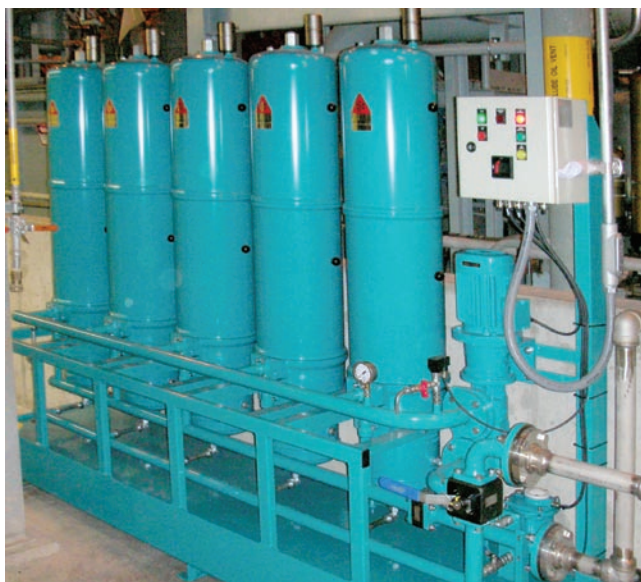
6. Steam turbine lube-oil conditioning system has five independent modules operating in parallel. Each has multiple filter inserts and a coalescer element

The lube-oil conditioning project at New Harquahala began with the steam turbine, so the steamer is a good starting point. Its lube-oil sump contains 4600 gal of ISO 32 turbine oil. System selected has five independent conditioning modules operating in parallel (Fig 6) that are served by a 23-gpm motor-driven pump (lower right in photo). Each of the modules has multiple filter inserts and a coalescer element.

Dirt holding capacity of the integrated system extends up to 300 lb, water separation capacity is unlimited, and oxidation-product removal capacity is at least 160 lb. Specified oil cleanliness is 14/10 or better, where the 14 is indicative of the number of particles larger than 5 microns and the 10, particles larger than 15 microns.

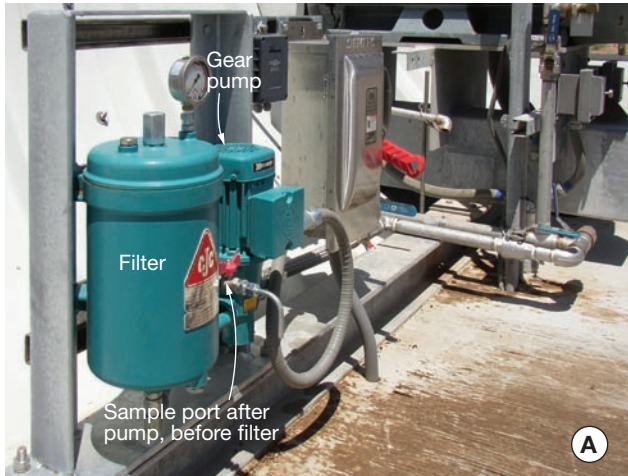
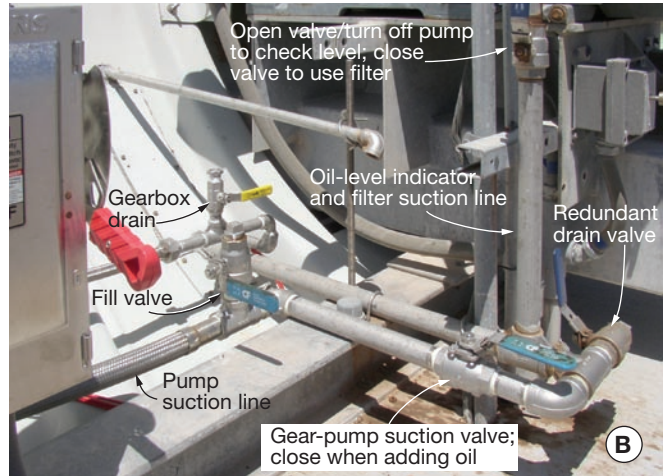
7. Gearbox oil conditioning system is relatively simple and inexpensive, and effective

Arrangement of the gearbox oil conditioning system is shown in Fig 7. Note the three-way valve on the suction side of the pump. It enables addition of oil to the gearbox, via the filter, even while the fan is in operation. The pump is the only moving part in the system.

"That was an incorrect assumption. When the pump is in operation, I lose visual level indication. This means the pump must be turned off and the isolation valve closed to get an accurate level indication [as noted in Fig 7B]. I plan to run a separate line at some point." CCJ
