Water-removal Solution Brings Sweet Savings to Cane Processor

Central Azucarera de La Carlota Inc. (CACI) is a 93-year-old sugar cane processing company based in Negros Occidental in the Philippines. Recently, the company has been under pressure to improve efficiency due to the impending removal of protective import tariffs, rendering its products non-competitive against cheaper imports.

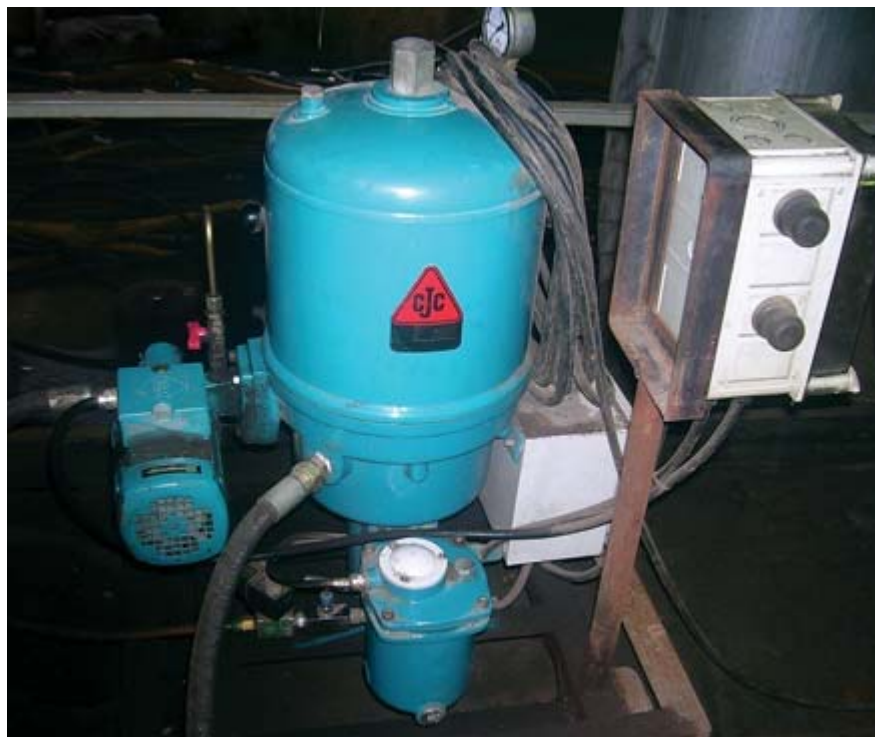
Figure 2. This water separator unit utilizes the coalescing principle coupled with a fine-depth cellulose filter with Beta 3 > 75 to remove particles and emulsified water.

The company decided to install an offline filtration system that can remove particles, water and varnish at the same time. It also started using oil analysis differently. Instead of just checking if the oil is still suitable for further use, it checks machine condition and contamination closely. In effect, the processor has shifted from interval-based to condition-based maintenance.

The crucial point came when CACI had to suspend the recycling of the oil due to unavailability of the filtration unit; the oil turned milky in a matter of days. The plant realized it could not run the turbine without the filtration unit and thus decided to acquire a dedicated unit for the application.

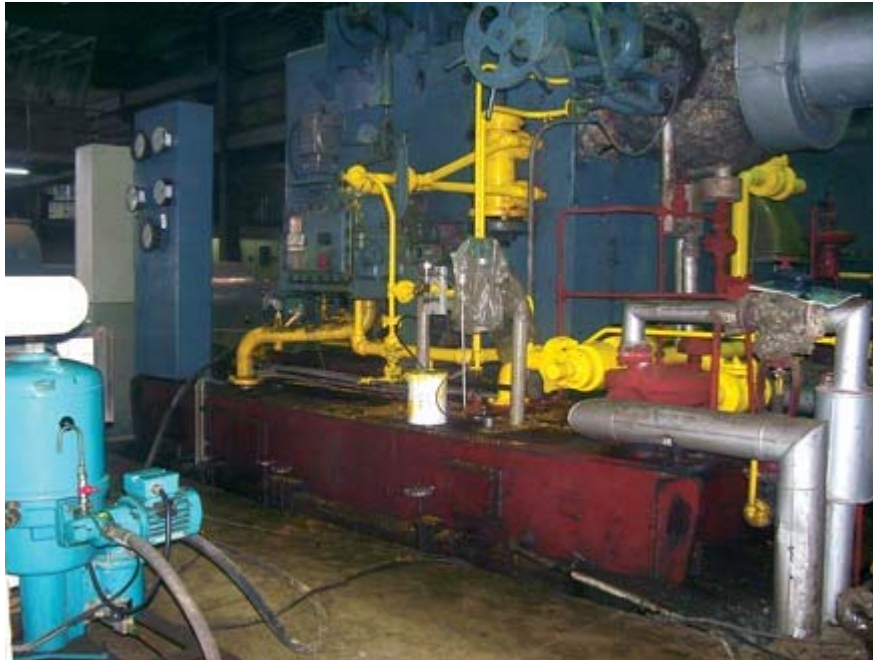
Figure 3. The water separator unit was installed adjacent to the 5-megawatt Turbodyne steam turbine.

CACI used to replace more than 2,200 liters of oil every six months. Today, the oil remains in good health, fit for at least another crop year. The cane processor also managed to extend the mean time between failure of its Babbitt bearings from replacing three each year to replacing none following the intervention. That equates to higher productivity. The company is saving close to 21 man-days that previously were spent each crop year repairing and replacing damaged components.

Also, the company used to encounter periodic short tripping incidents due to low oil pressure, attributed to the presence of water corrupting oil pump clearances and oil film strength. These incidents led to a production downtime worth more than 500 tons of lost cane production. With the filtration unit, it hasn't experienced such an incident throughout the crop year.
