Hydraulic Oil Hydro Turbine

CJC™ Application Study

Statkraft, Region Nord-Norge.
Contact person: Torstein Elvegård

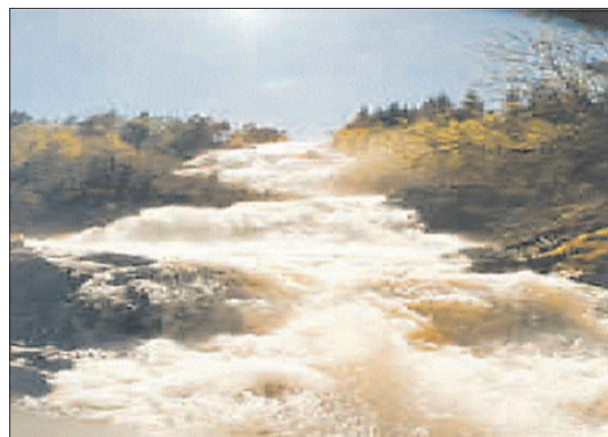
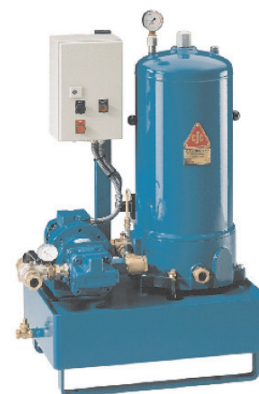
CJC™ Fine Filter HDU 27/54 MZ

In order to arrest the problems and ensure continuous operation a **CJC™ Fine Filter HDU 27/54 MZ** was installed. Two cellulose based **CJC™ Filter Inserts B 27/27** (3µm absolute) were used.
