**CLEAN OIL
BRIGHT IDEAS**

CJC™ Application Study

CORUS Ijmuiden, The Netherlands. Power Plant
'Centrale 2'.

Turbine Oil Turbo-vane, Gas Boiler

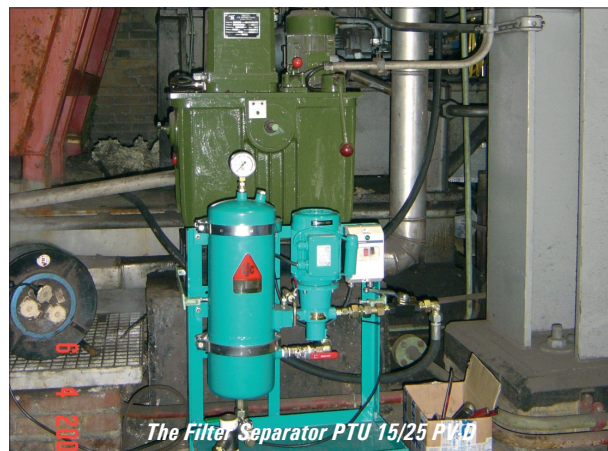
CJC™ Filter Separator PTU 15/25 PV-D with manual motor starter, a pump flow of 30 litres/hour and CJC™ Filter Insert BLA 15/25 (3 micron absolute). The suction line is connected to the drain of the oil sump and returns clean oil back into the system. Water separation is done by the CJC coalescing element that is manually discharged during a weekly inspection. On average 500 ml of water is discharged from the CJC Filter Separator every week. From 29th August to 25th October 2004 a total of 3,920 ml water was discharged, measured and collected by CORUS employees under supervision of Mr. Piet Pepping.

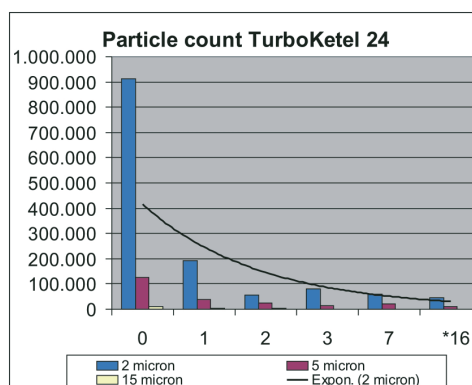
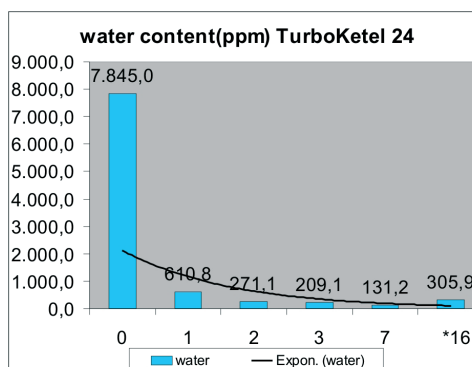
After 7 days the water contamination was under control and particle contamination was reduced to ISO Code 16/14/10. The first oil sample included a large quantity of sludge, resins and particles which coloured the oil dark brown. After 16 days the oil became clear and light coloured. Cost savings were made from extended service intervals, less manpower, less oil usage and most importantly less down time. The life of components, bearings and valves were extended by a factor of four. Return of investment within six months.

Before	1 Day	3 Day	7 Day
Particles > 2 µm	910,000	190,000	80,000	50,000
Particles > 5 µm	110,000	40,000	20,000	15,000
Particles > 15 µm	10,000	5,000	2,500	600
ISO Code	20/17/14	18/16/13	17/15/12	16/14/10
Water content, ppm	7,845	610	209,1	131,2
